Documenting the current pollution patterns on the Cathedral of Learning

Documenting the Current Pollution Patterns on the Cathedral of Learning

EDRC 05-83-94

Abstract

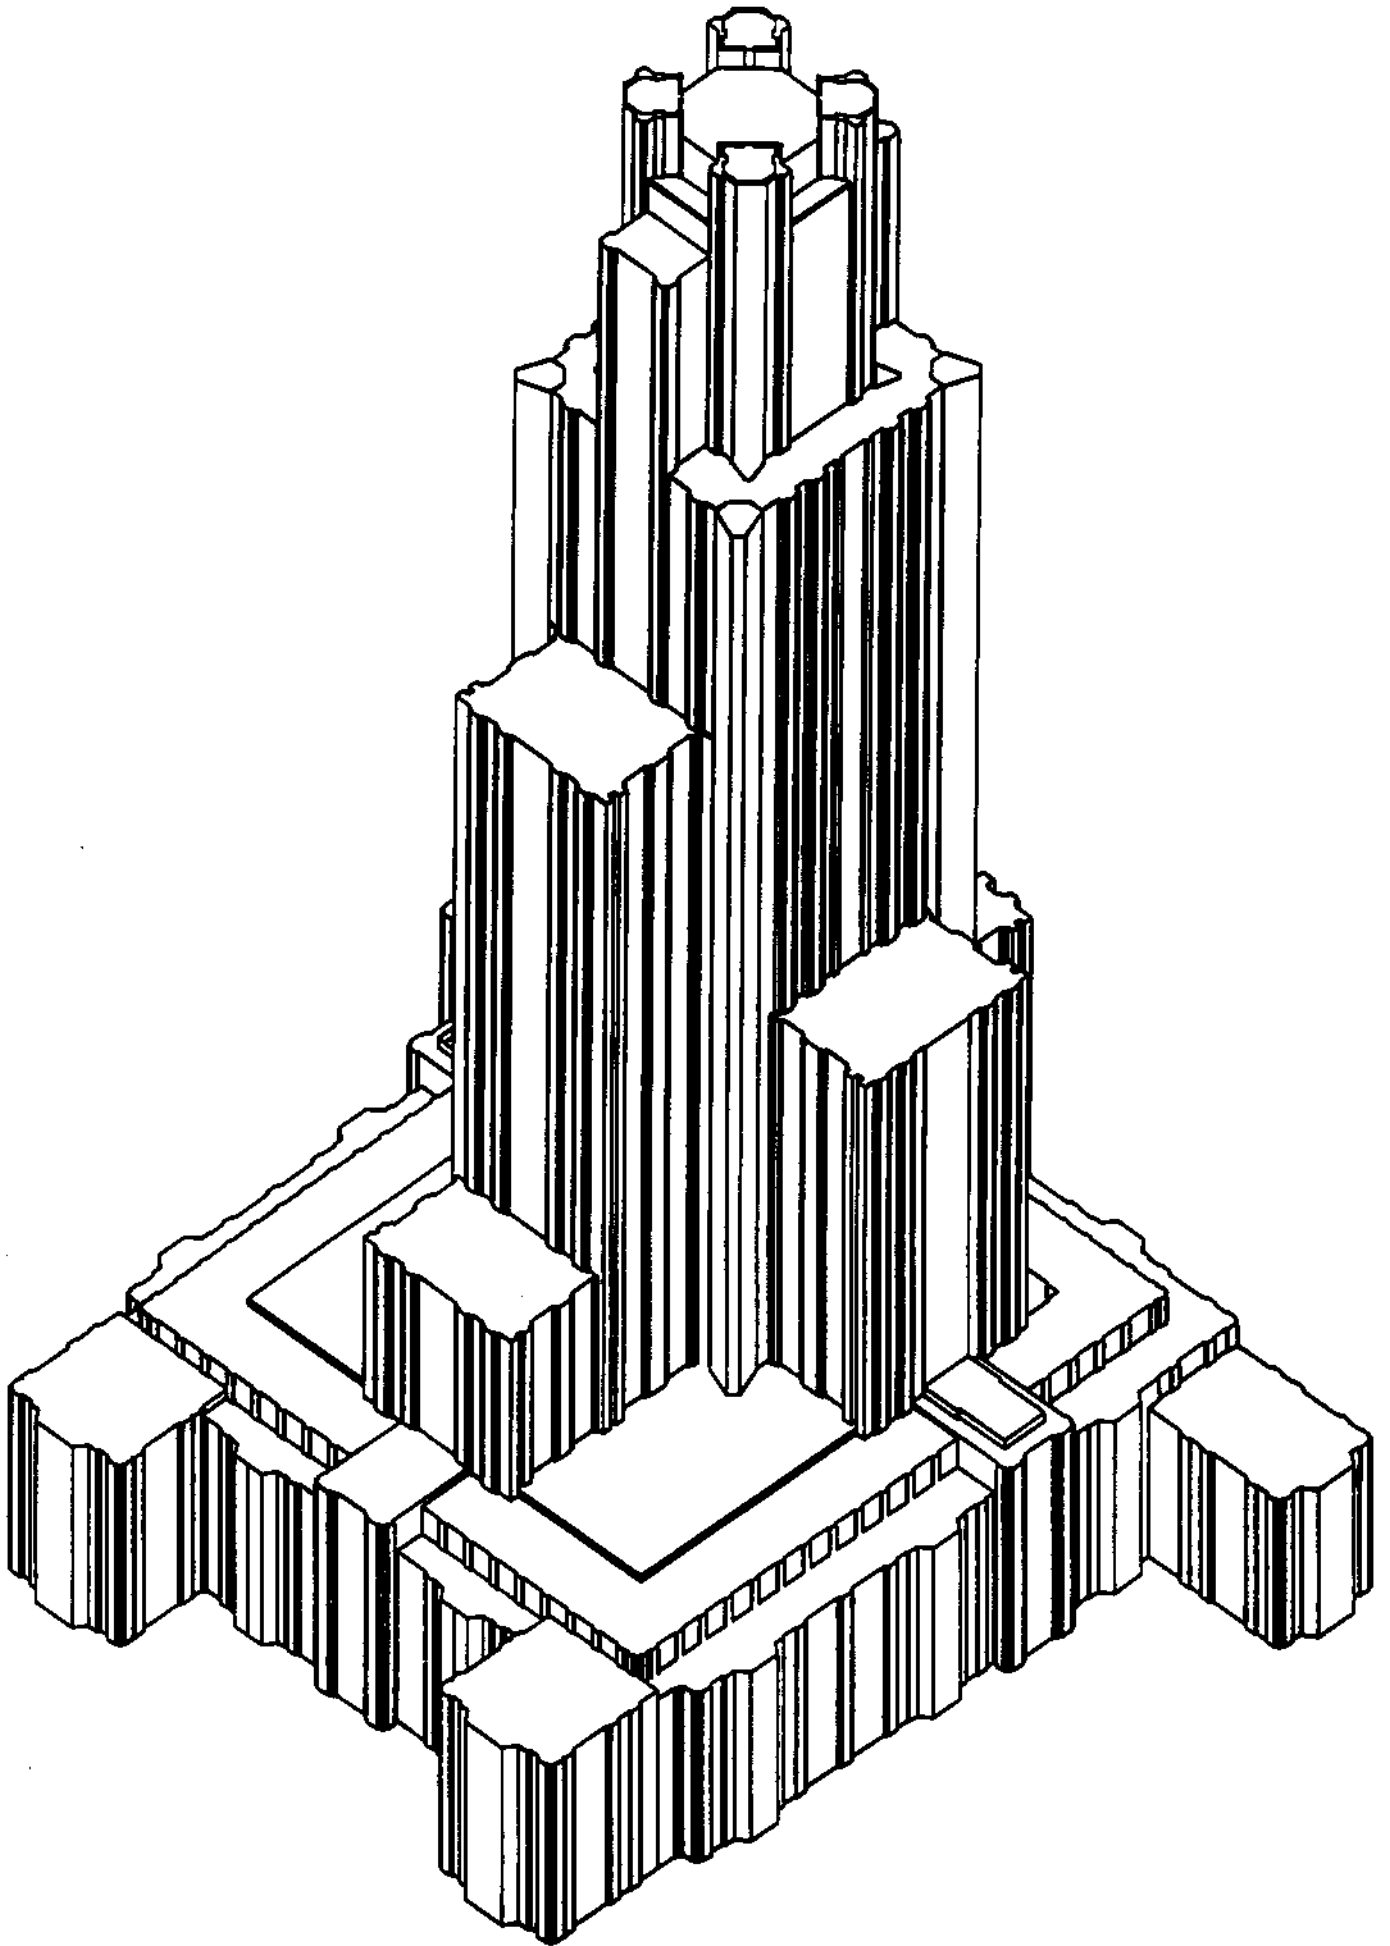
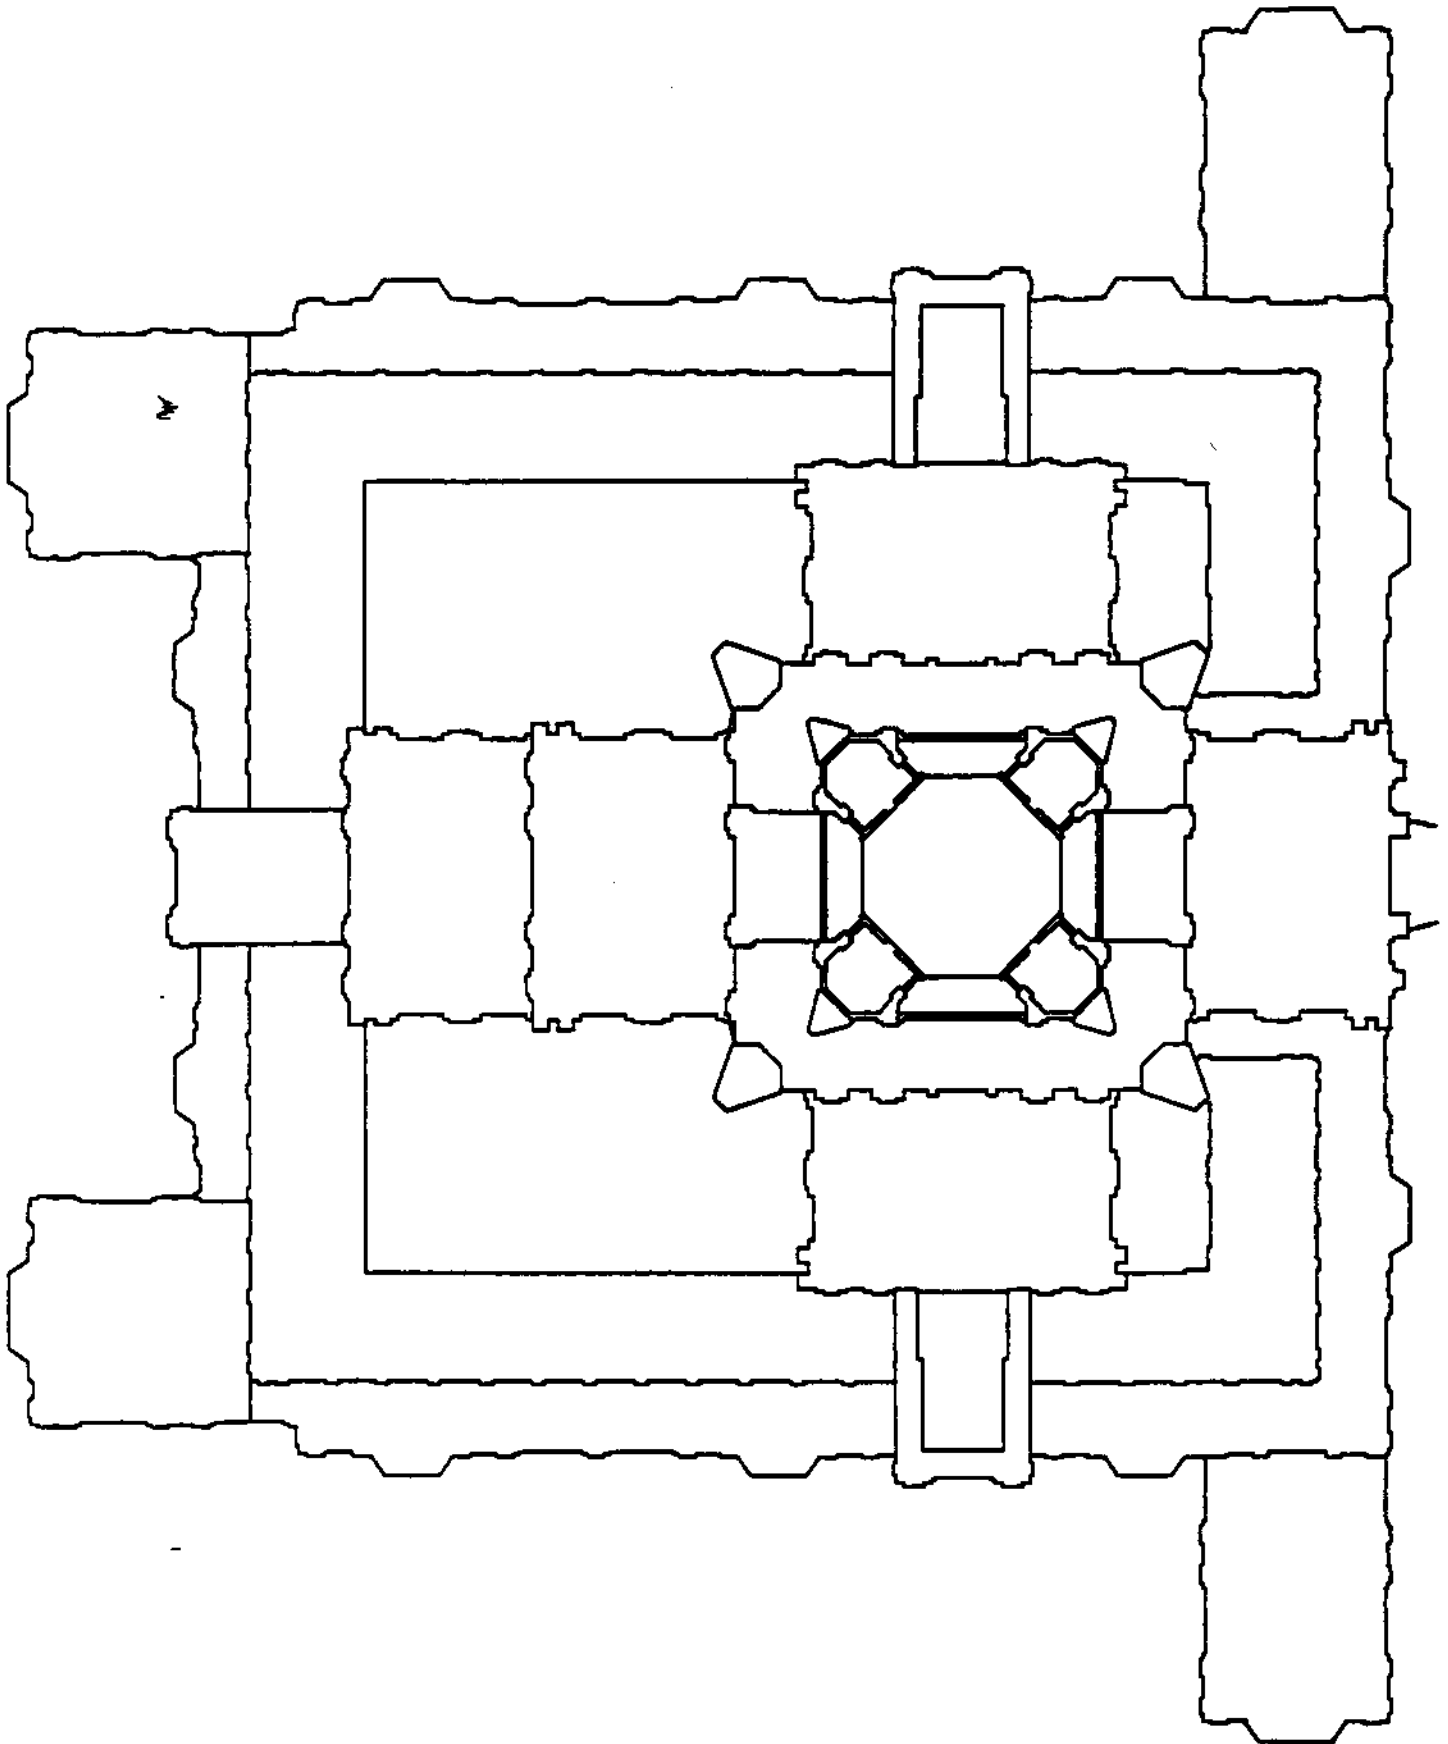
Appendix 3: AutoCAD Model

Eventually, a complete map of the pollution will be placed on the AutoCAD model. As of today, the windows are less important than the pollution, but may be necessary for future studies. Because the surveying, photography, and sketching were the main focuses of the project, the AutoCAD received less attention and time than the other parts of the study. But because researchers now know the problems with mapping the pollution, and because a computer program was developed to convert the different coordinate systems, future work will be much easier.
